LARGE CAPACITY WATER TANKS

PROJECT DATA

Location	Whyalla, South Australia
Contractor	AFL Services
Client	SA Water
Products	Denso Petrolatum Tape
Date	Approx 50 years ago
Ref No	E014

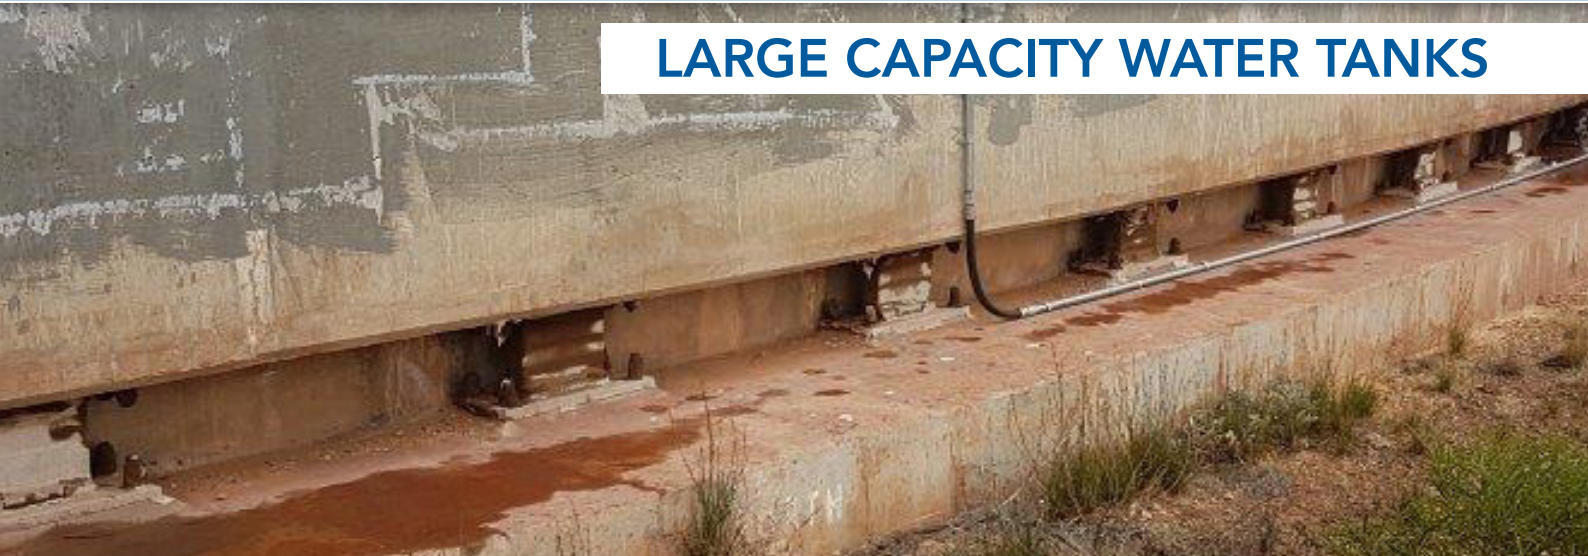
The design of these tanks incorporated a roller system to allow for both thermal and pressure related expansion and contraction. The rollers were set into the concrete and after some 50 years of service the concrete surrounding the rollers has carbonated which has caused the concrete to fail. The concrete areas required to be repaired in order to reinstate the structural integrity of the tank wall.

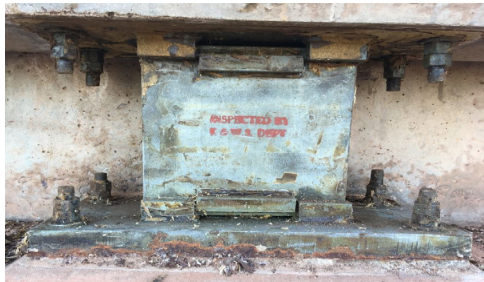
Bare roller showing no signs of corrosion

Upon inspection it was noted that the rollers had been protected using the Denso petrolatum system. The petrolatum tape was removed to inspect the condition of the steel. The steel under the petrolatum tape was still in perfect condition. In fact, the original stamp used by the SA Water inspector was still clearly visible. This is a testament that the Denso Petrolatum tape was still protecting the steel structure some 50 years down the track.

The Denso tape has been reinstated using Denso Hi-Tack tape with an Elastomeric topcoat. This updated system should enable the steel to live out the life of the concrete tank and continue to protect it well into the future.
