LONG-TERM PROTECTION TO ATON AND SUBSEA TRIPOD

Location	Port Walcott, WA
Contractor	Oceanic Offshore Pty Ltd
Client	Rio Tinto
Products	Denso SeaShield 70 System
Date	Dec 2019
Ref No	S042

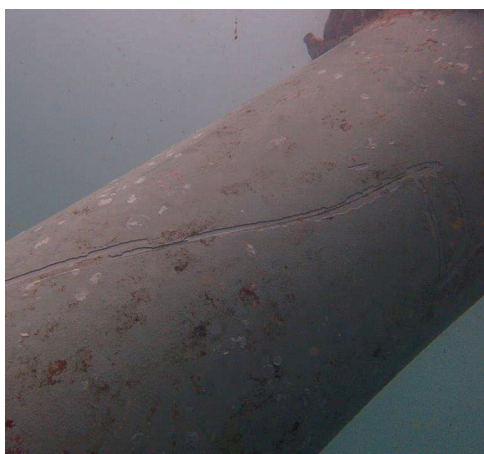
Damaged subsea tripod leg coating requiring protection.

Additional damage was caused when the mast fell over and made contact with its subsea tripod support structure's coating system, exposing raw steel. The mast to tripod connection flange, also required its corrosion prevention system to be re-applied once the mast was reinstated onto the tripod Structure.

A solution was provided by Denso Australia utilising the Denso Seashield 70 System, a combination of Marine Piling Tape & Denso Glass Outerwrap. The project which included the repair and re-installation of the AtoN Mast was successfully completed and the asset was returned back into service shortly thereafter.
